Rudy R. Christian

Resurrecting the Detroit Central Farmers Market

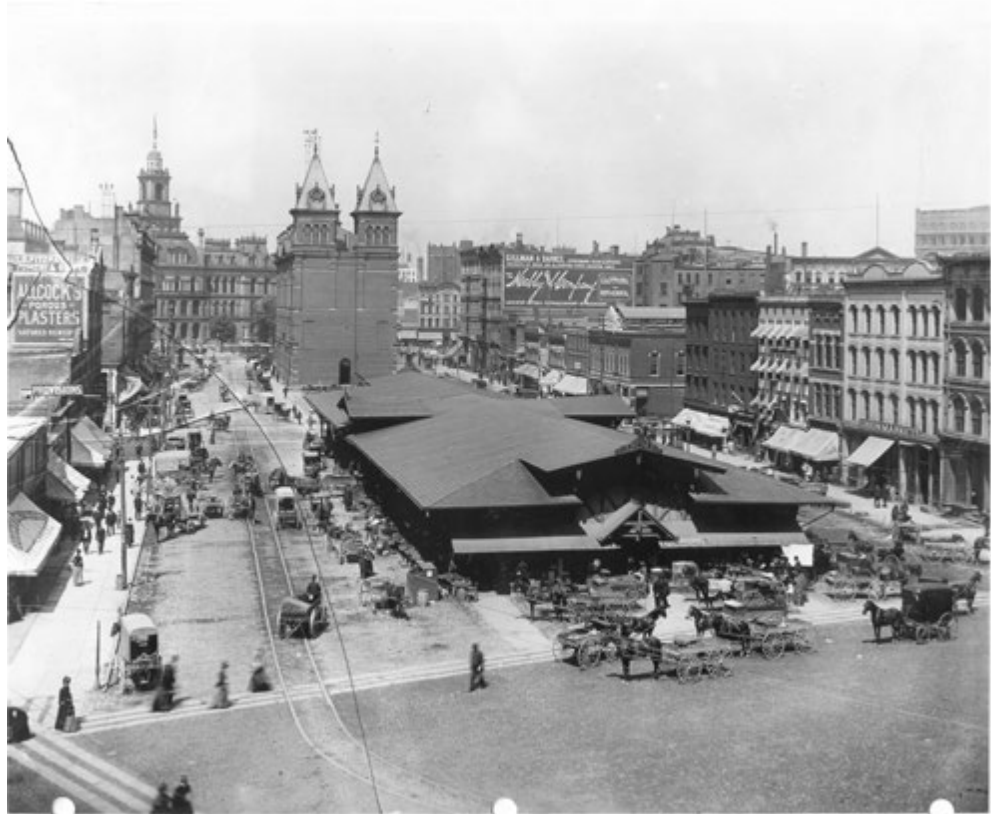
Figure 1. The Detroit Central Farmers Market with the timber-framed vegetable shed in the foreground and the masonry meat market in the background, c. 1880 (From the collections of The Henry Ford)

The Detroit Central Farmers Market was built by the City Council as a matter of civic responsibility. The city had grown a lot since the opening of the Erie Canal in 1825 and the railroads that soon followed. What had been a small trading center and fort grew into a thriving hub of agriculture and forestry. In 1860 Detroit Mayor Christian Buhl stated that “Our public markets should be far improved so as to offer protection from the inclement weather to those compelled to do business upon them.” Architect John Schaffer, originally from Austria, was hired to design the market building. Joel Gray was hired as building contractor and by September of that year the market was nearly complete. It was praised by the *Detroit Free Press* as “...an ornament as well as a great convenience to that important branch of city commerce” (Fig. 1).

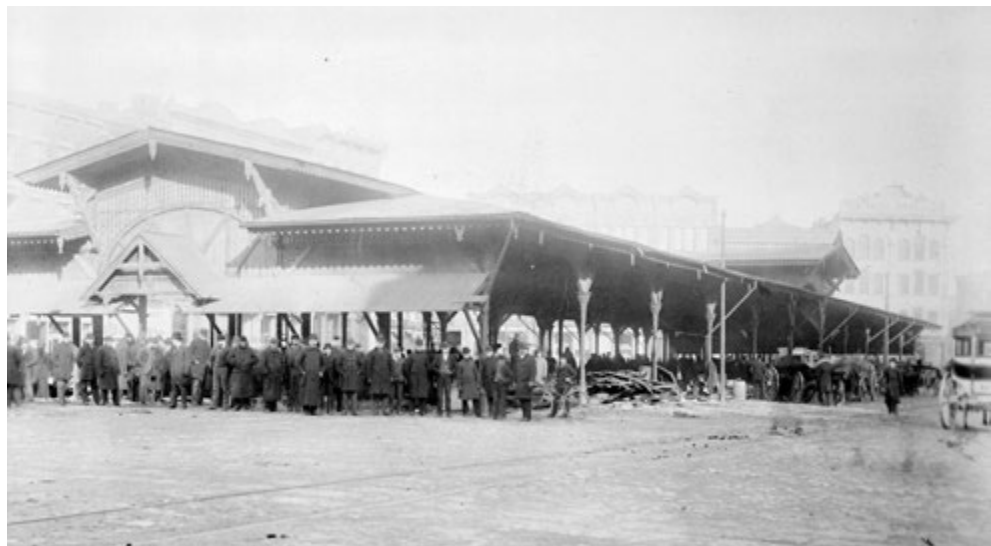
Figure 2. The timber frame market building being deconstructed in 1892 under police guard (From the collections of The Henry Ford)

Detroit continued its rapid growth and by 1890 it was a major industrial center. At the heart of the city that had grown up around it, in what is now Cadillac Square, the market was becoming a problem. Farmers' wagons and horse carts were causing congestion and agriculture was no longer seen as vital to civic prosperity. The Eastern and Western Markets were beginning to take over from the Central Market and in 1892 the latter was closed – but its closure met with resistance and its occupants had to be forcibly removed by police (Fig. 2).

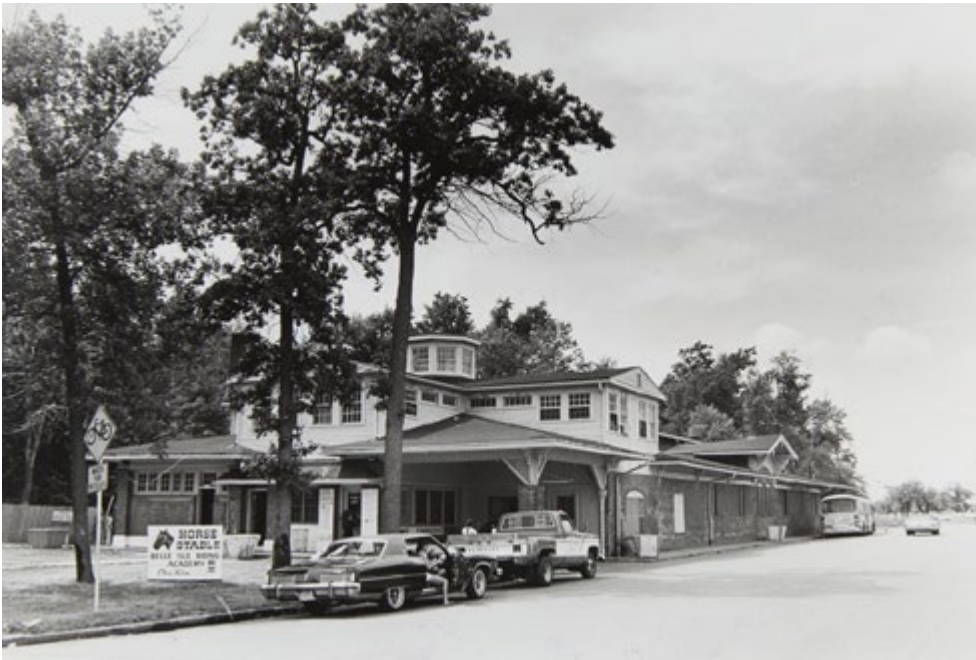
Figure 3. The Belle Isle Riding Academy still in use in 1978 (From the collections of The Henry Ford)

Rather than demolishing it, the city transferred ownership of the market building to the Parks and Boulevards Department, so it was carefully dismantled and reconstructed in 1894 on Belle Isle, Detroit's main park. It was used as a stable and park-vehicle shed, and then when horses were no longer required for city services it was leased to the Belle Isle Riding Academy. Significant modifications were made, including the addition of brick walls to the perimeter. A full-length monitor roof was installed to let sunlight into the now enclosed building. Horse stalls were added inside and offices were created on both the first floor and an added second floor (Fig. 3).

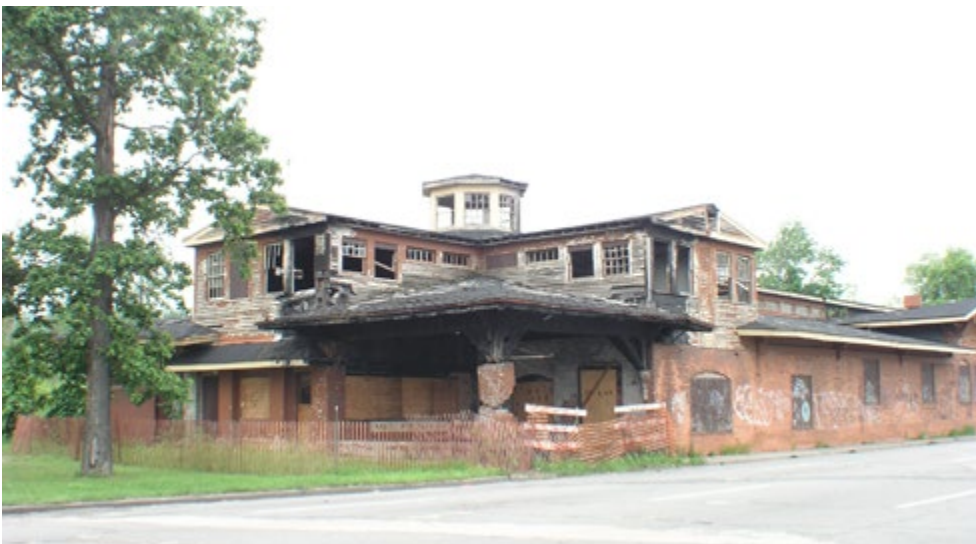
Figure 4. The abandoned Riding Academy building showing evidence of the car crash and ensuing fire as well as general dilapidation in 2003 (Christian & Son, Inc.)

Recreational tastes changed in the late twentieth century and horse-riding slowly fell out of fashion, and by the 1990s the building was abandoned and falling into disrepair. A car had run into it, causing a fire which was thankfully extinguished. The place had become derelict and efforts to restore it never gained traction. But before its demolition was scheduled, it was offered to the Henry Ford Collection, and in early 2003, Jim McCabe, then curator for Greenfield Village, was asked to take a look at it. From outside, the building clearly did not appear worth including in Henry Ford's Collection of American Innovation (Fig. 4).

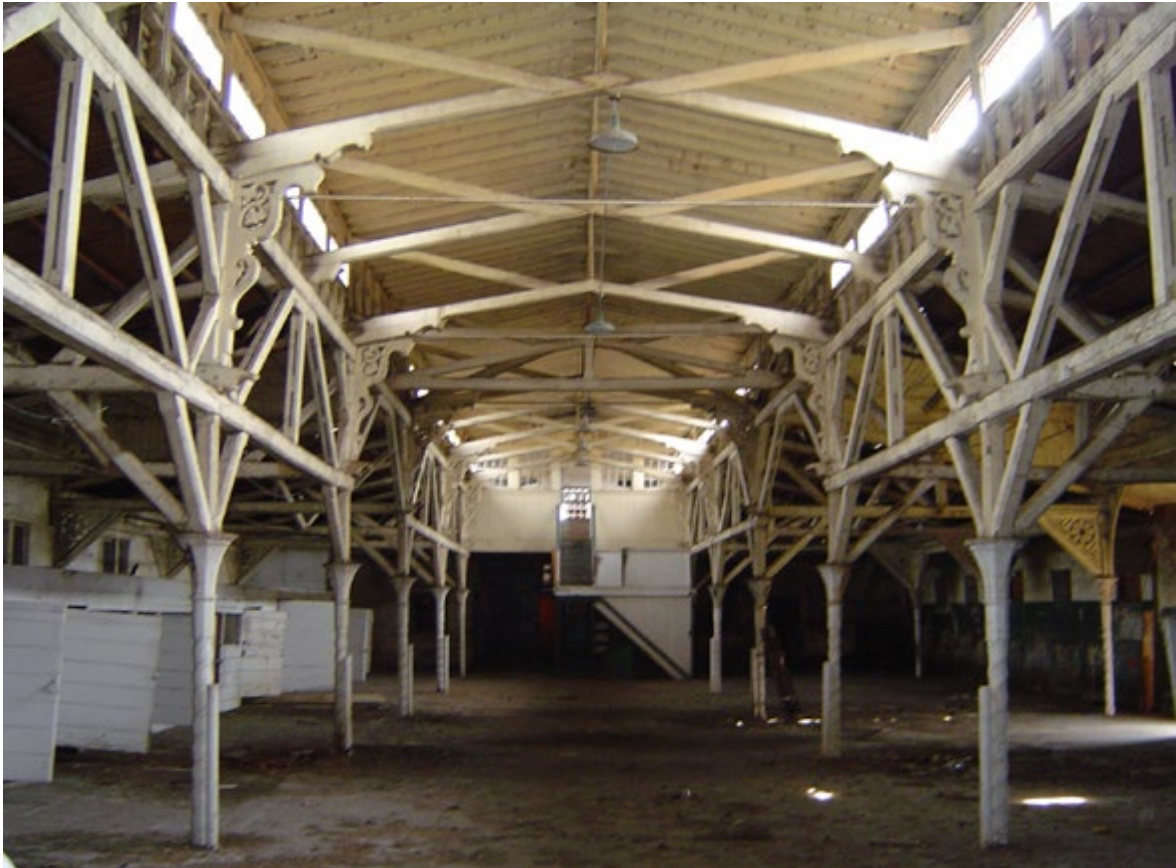
Figure 5. The interior of the Riding Academy building revealed a very well-built and highly decorated timber frame plus the added monitor and support framing (Christian & Son, Inc.)

In April 2003 Jim McCabe invited me – Rudy R. Christian, President of Christian & Son, Inc. – to visit the building to help him decide if it might be worthy of the Collection, and if it could be dismantled and salvaged. What was inside was magnificent. The timber-frame structure was an outstanding example of its type in the mid-nineteenth century and the decoration was amazing. The braces along the perimeter were adorned with hand-carved filigree “snowflakes”. The bolsters under the two-piece rafters were supported by hand-carved brackets, and every timber in the structure was carved with chamfers and stop chamfers (Fig. 5).

The challenge in documenting and deconstructing the market building was to determine what was part of the original structure and what was not. It had undergone slight alterations in 1894 and major ones later on, and when the weight of the monitor roof system was added, plank trusses had been installed between the original purlin posts. Those were easily discernible, but the damage done to the original down braces would have to be repaired. Luckily the original rafters were left in place below the monitor. And when the brick walls were added, the masonry was laid around the decorative rafter ends, so most of these also survived. But when the second-floor offices were added, the upper rafters, bolsters, and bolster brackets were removed and discarded, as were many decorative details in the office area. All these would have to be remade. The decision was taken to deconstruct and document the historic components and to put them in trailers for storage on Greenfield Village land.

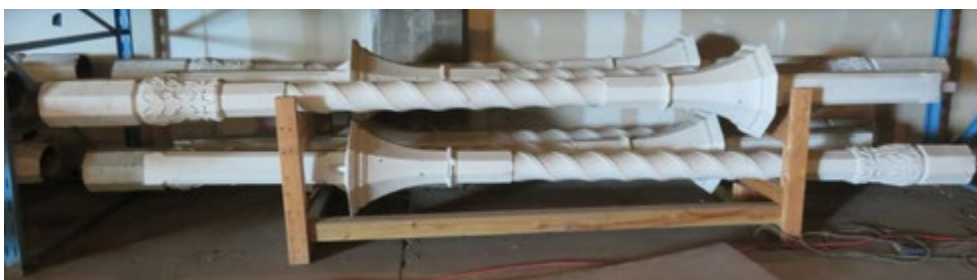
Figure 7. The original cast-iron columns were cleaned, prime-coated and put into storage (Christian & Son, Inc.)

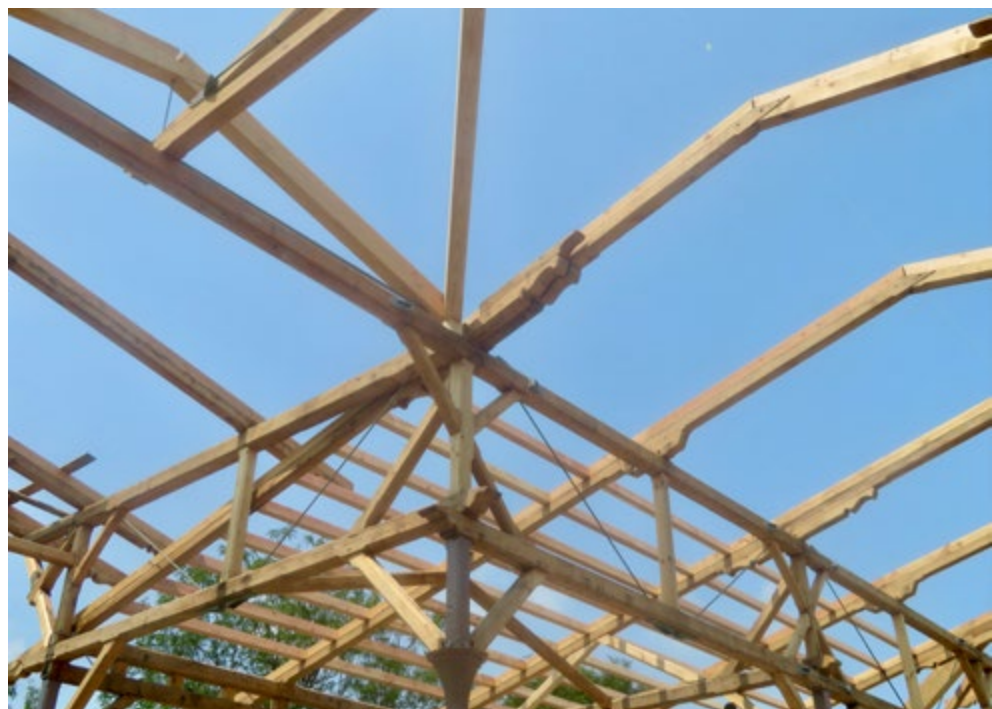
Figure 9. View of the finished frame showing the added compression post/tension rod system installed (Christian & Son, Inc.)

Douglas fir also does not hold paint well, and the entire frame was to be painted to match the historic colors. Ben specified glue-laminated southern yellow pine for any timbers needing to be replaced or remade. He too was concerned about the historic timbers handling the loads required by modern building codes and so a system of tension rods and compression posts was added (Figs. 8 and 9). He also devised a way of moving the moment frame into the foundation, eliminating the need for steel in the roof. Thus all the restorable historic timbers could be used.

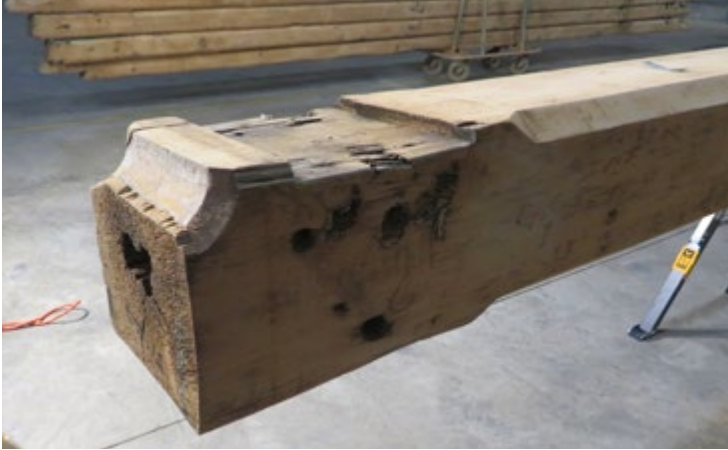
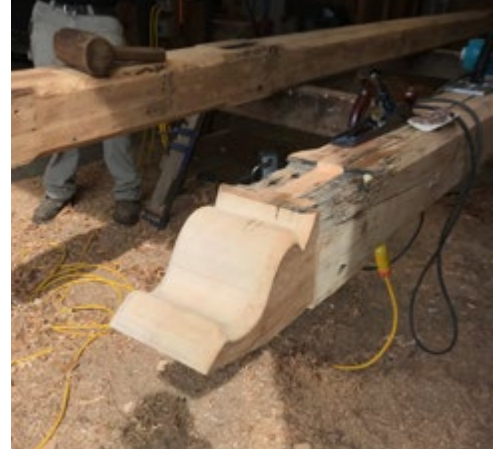
Figures 10 and 11. The decorative ends of timbers removed in the twentieth-century alterations would require replacement, using sections salvaged from other parts of the frame (Christian & Son, Inc.)

Following the decision to reuse the historic timbers, a plan was created to minimize material handling. Being pine, the timbers were prone to impact damage, and considering their importance, the less they were handled the safer they would be from mishaps. As the timbers were documented and reassessed in the Romulus warehouse space they were sorted according to whether they needed no repair, minor repair, or significant repair. The latter were shipped to Christian & Son's shop in Burbank, Ohio, and the rest remained at Romulus, where a satellite workshop was created for minor repairs. Several of the historic timbers had considerable cosmetic damage, and decorative ends had been cut off in the modifications to create offices (Fig. 10). These ends were replaced with sections of unused timbers salvaged from the market frame and joined to the timber being repaired with blade-and-fork joints, sawn with a portable band saw and chamfered to match the original pattern (Fig. 11).

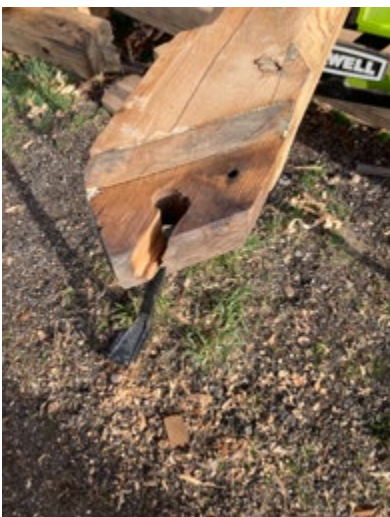
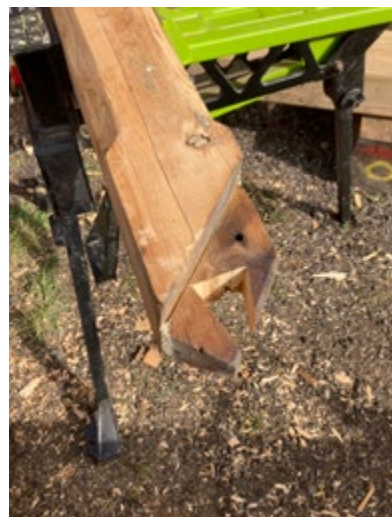
A common structural repair in historic timber-framed buildings is to fix "relish blowout". This is primarily the result of racking forces causing movement which puts the braces under strain, although it can also occur as the frame is raised or dismantled. The example shown was probably caused by improper handling by the deconstruction crew because the missing wood has surfaces with no

Figures 12, 13 and 14. Brace tenons with "relish blowout" and dovetail infills (Christian & Son, Inc.)

patina, whereas if it had happened earlier there would likely be darkening of the broken surface. To make a strong repair without the use of fasteners, a dovetail section was removed from the brace tenon. The matching long-grain repair piece, cut from a salvaged timber, was secured with urethane glue and fixed in place in the brace mortise (Figs. 12, 13, and 14). In some cases the tenon was more severely damaged and had to be replaced. And when the plank trusses were installed in the early 1900s to support the monitor roof, the noses of the braces attached to the lower purlin were cut off so that the built-up struts could abut against them. But as the building was being shortened by four bays, we had surplus braces to work with, and so we removed the damaged ends and created blade-and-fork joints to make one good brace from two damaged ones (Figs. 15, 16 and 17). These joints were secured with urethane glue and all-thread trim-head structural screws.

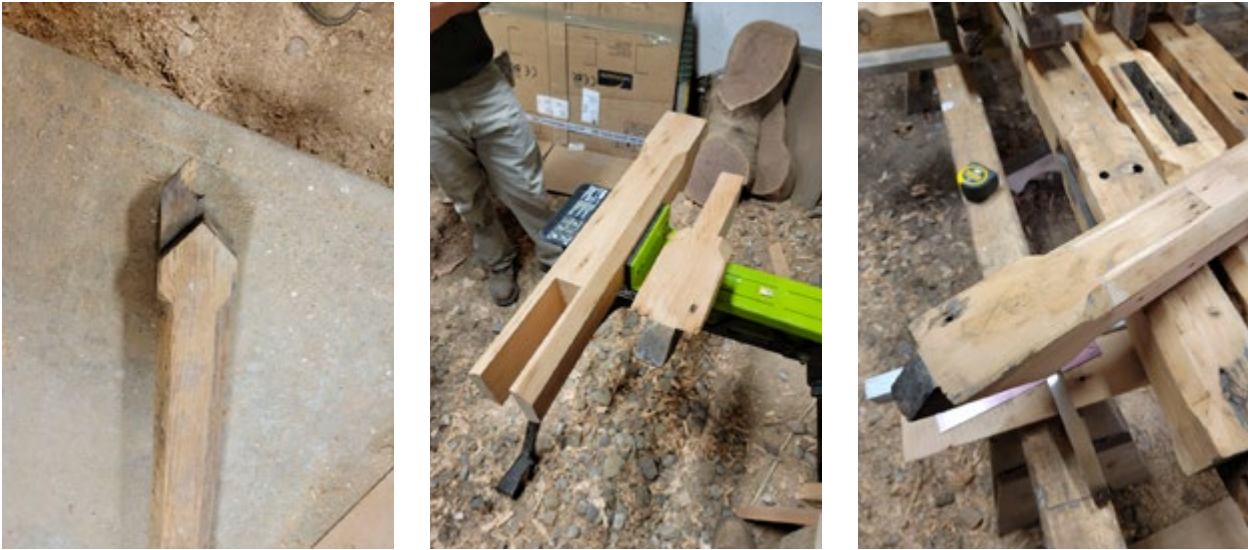
Figures 15, 16 and 17. Brace tenons damaged during installation of the added monitor trusses required blade-and-fork repairs with salvaged ends from damaged braces (Christian & Son, Inc.)

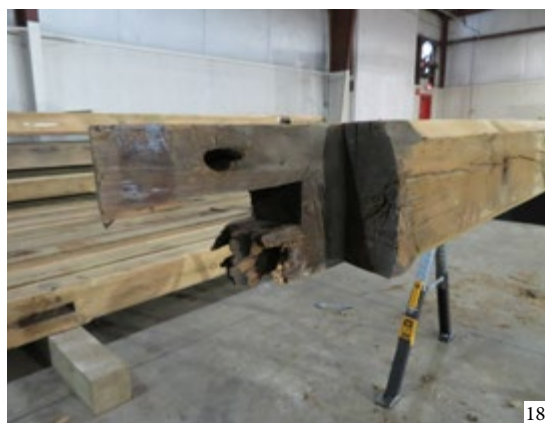
Figures 18 and 19. Damaged scarf joints required repairs that extended back into the solid section of timber (Christian & Son, Inc.)

Quite a few of the scarf joints (end-to-end joints to form longer timbers) were damaged and required full or partial replacement. This meant extending the repair back into solid sections of the timber and creating a matching section of scarf joint with an “undersquinted” abutment to lock the repair in place and withstand axial loading (Figs 18, 19, and 20). These repairs were secured with urethane glue and GRK structural screws, whose head holes were later plugged. A challenge arose when the engineering team determined that the hips and valleys all required replacement glulam timbers with double-depth section. This was accomplished by extending them up into the common purlin over-structure concealed by the beadboard ceiling. The valleys terminated in the roof structure but the hip timbers extended out in nearly 4-foot overhangs, which required carving of decorative ends to match the originals. Figure 21 shows glulam hip timber ends carved to match the original hip in the foreground. The hip affected by the fire caused by the car accident can also be seen in the foreground.

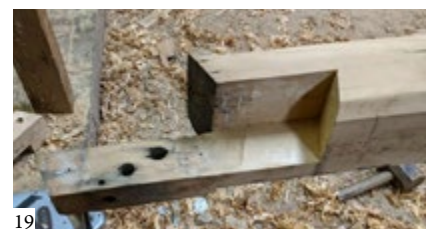
Figure 20. Infill repair installed with an undersquinted abutment (Christian & Son, Inc.)

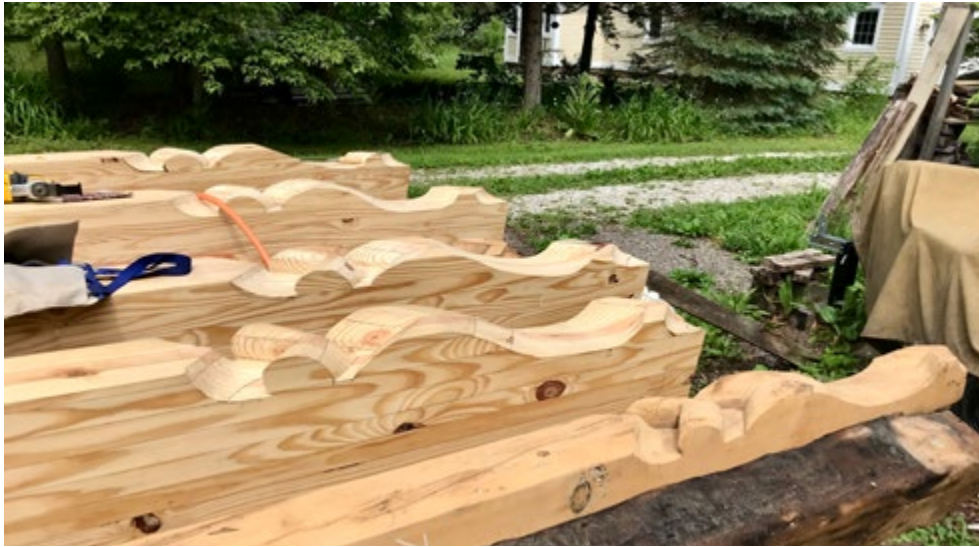
Figure 21. The deeper glulam hip timbers needed matching decorative ends duplicating the original pattern (Christian & Son, Inc.)

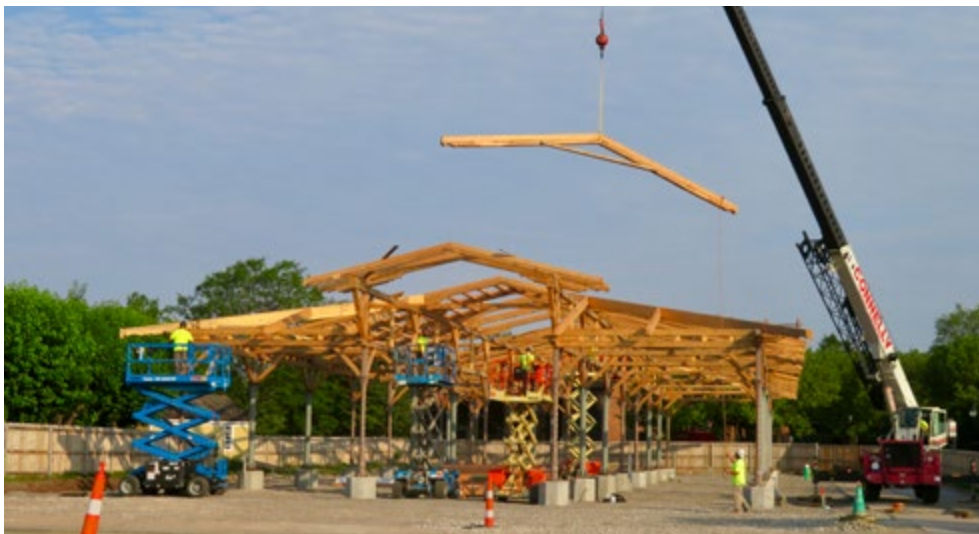
Figure 22. As the historic roof frame sat on top of 15-foot cast-iron and steel columns, installation had to be done with manlifts, extendable forklifts and a crane (Christian & Son, Inc.)

After repairs and replication work, the timbers were shipped to the building site in Greenfield Village in Dearborn, Michigan. The fact that the timber roof system sat on 15-foot tall steel and cast-iron columns meant that all the installation work had to be done with manlifts (Fig. 22). Extendable forklifts were used to bring the timbers into position and the roof system was assembled piece by

piece. The braces were pegged in place with traditional treenails, but the engineering drawings specified Rothoblaas all-thread structural screws imported from Italy for securing the rest of the joinery. The screws were fitted so as to be unseen from the ground. Some 80% of the original timbers were able to be reinstalled in the structure. Once the roof sheathing was installed, slate shingles matching the originals were laid over the roof (Fig. 23). The entire frame was painted to match the original color, concealing the replacement timbers. And after nearly 20 years of storage, the Detroit Central Market now stands in Greenfield Village where millions of visitors will be able to view the incredible work of craftspeople working entirely with hand tools over 160 years ago and get an insight into how buildings were built when they were made to last for generations (Fig. 24).

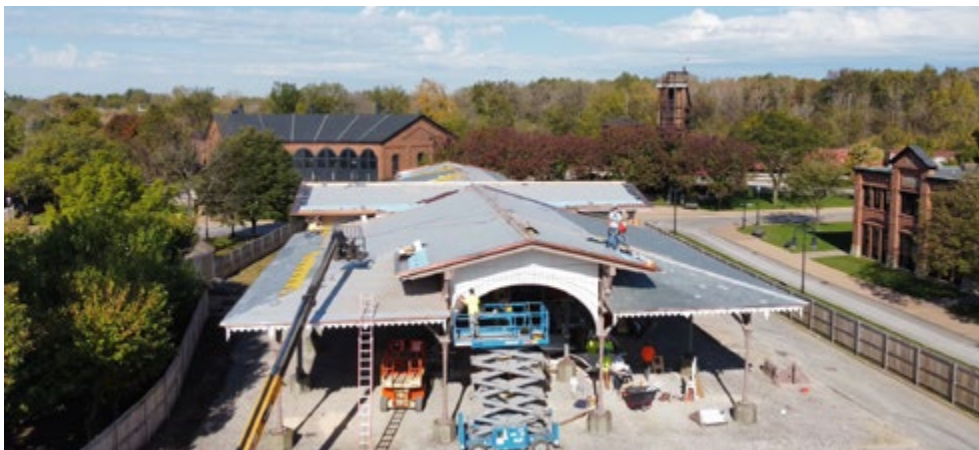
Figure 23. Drone view of the building and surrounding area as slate roofing began (From the collections of The Henry Ford)

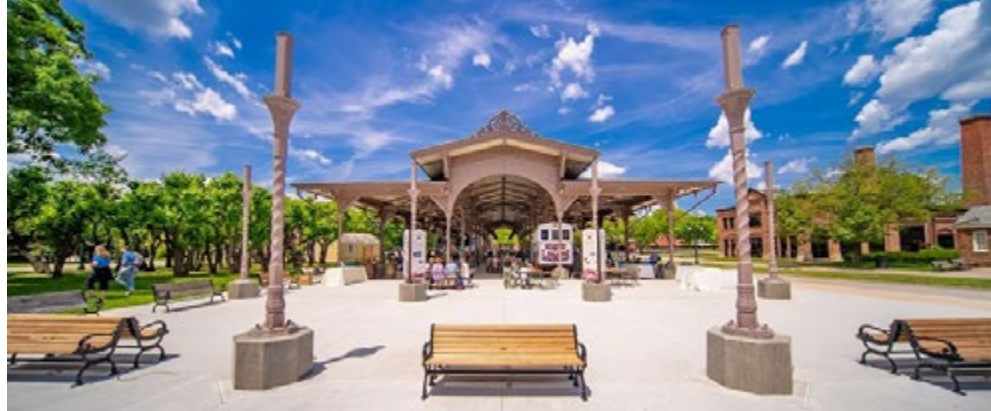
Figure 24. Completed market building with added rows of salvaged cast-iron columns to give visitors a sense of its original size (From the collections of The Henry Ford)

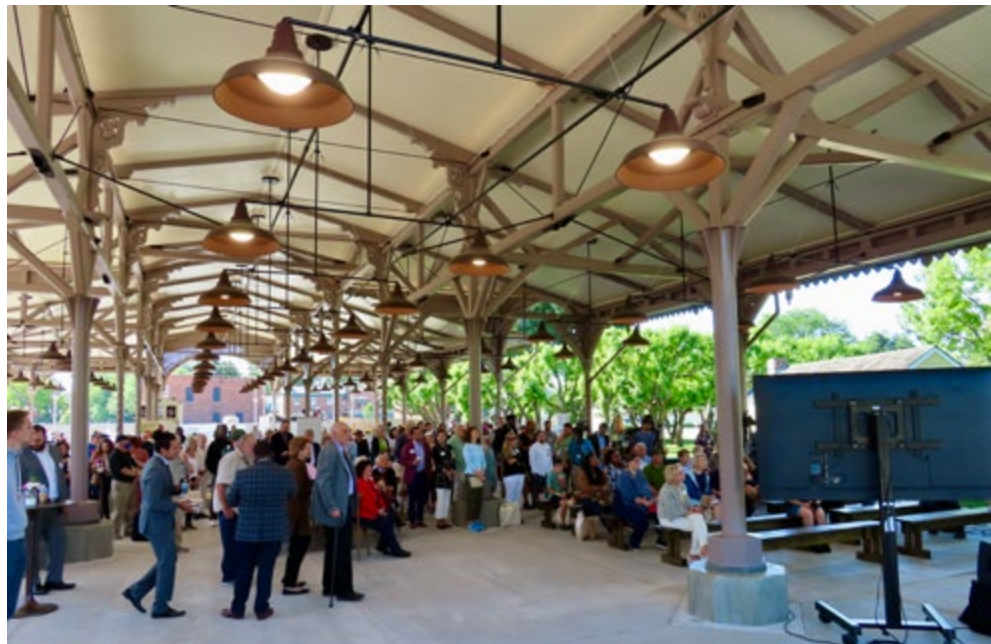
Interior view of the finished market during the grand opening, giving a sense of what it might have looked like in the nineteenth century in all its glory (Christian & Son Inc.)
