Martina Bocci, Beatriz Yuste

Recovering the heritage and building traditions of the village of Tacora, Chile

Abstract | Resumen | Resumo

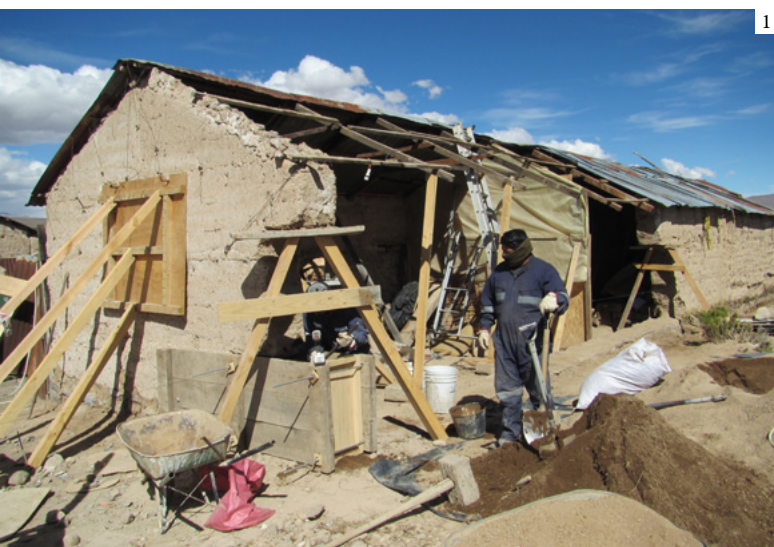
1

1: Process of reconstruction of a rammed-earth wall

The interventions employed local techniques and solutions, without altering the architectural character of the place. Missing or eroded stone basements were restored; collapsed or detached portions of walls were rebuilt; cracks and fissures were repaired with earthen mortar injections, filled with adobe bricks or with volcanic stones and earthen mortars. In some gables, masonry was replaced by lightweight *quincha*: a local traditional structure made of wood and reeds which is filled with a mixture of earth and straw.

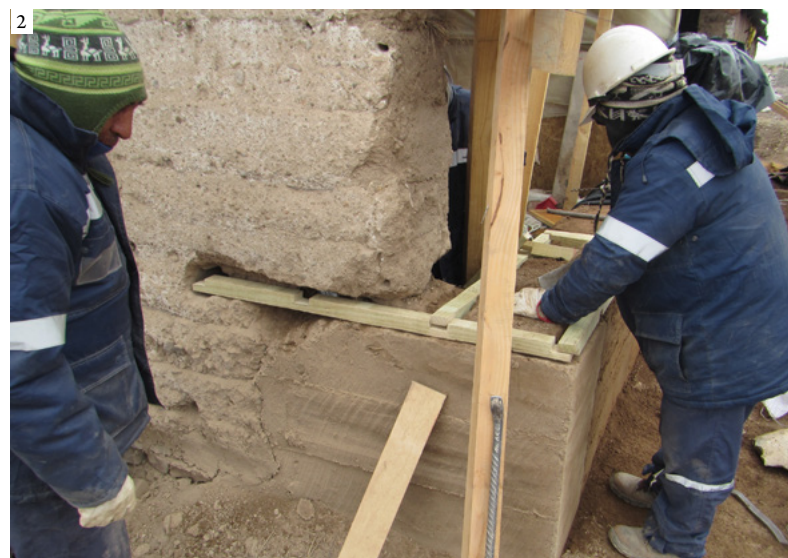
2

2: Wooden reinforcement of a rammed-earth wall

In order to improve the seismic resistance of the restored buildings, low-tech solutions based on studies by Julio Vargas Neumann – a professor at the Pontificia Universidad Católica del Perú – were used, such as biaxial nets, wooden reinforcements and geomats.
