Martina Bocci

Raw Earth Construction Perspectives in Italy: An Overview Through the Rehabilitations of Casa Fenu in Villamassargia, Sardinia, and Casa di Teresa in Casalincontrada, Abruzzo

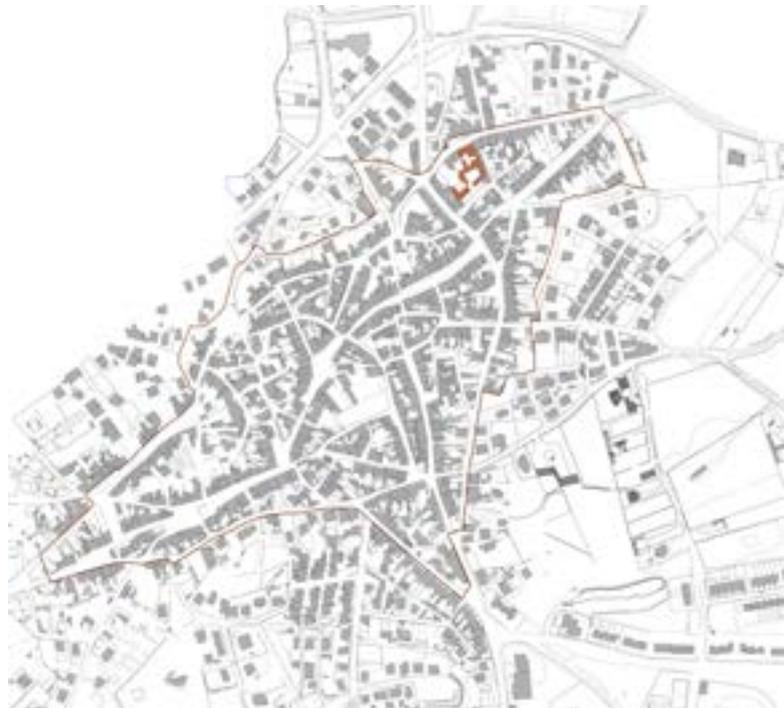
Figure 1: Historic centre of the medieval town of Villamassargia, in which 79% of the buildings are in *ladiri*. The Casa Fenu complex is marked in red.

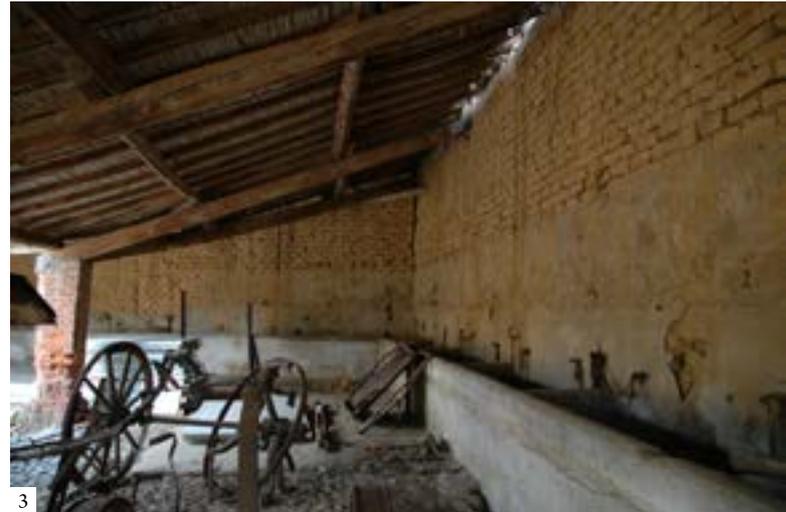
Figure 3: Outer walls of the oxen courtyard (II) in 2005 (Ignazio Garau)

Originally at the heart of a large farm of about 250 hectares, the family-owned Casa Fenu complex combines a dwelling with the functional needs of rural husbandry, with a sequence of three mixed-use courtyards connected by arched portals of fired brick (Fig. 3).

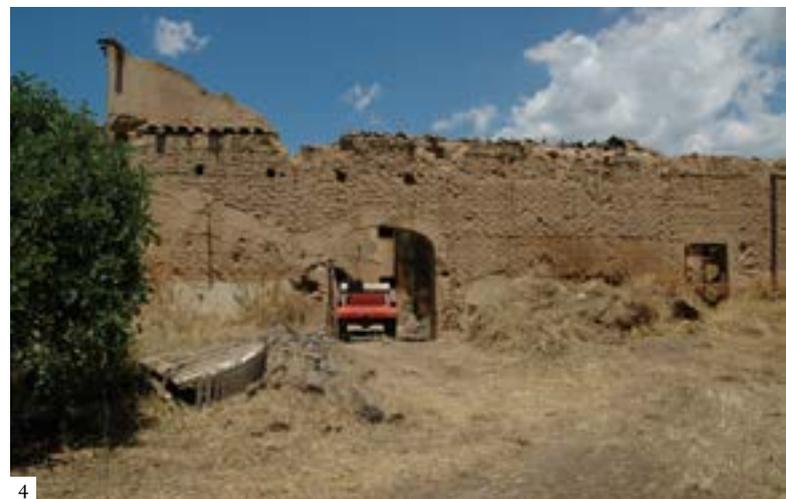
Figure 4: The arch between courtyards I and II in 2005 (Ignazio Garau)

The ox yard (II) was the center of the complex, with a portico for sheltering animals and storing materials (Fig. 4).

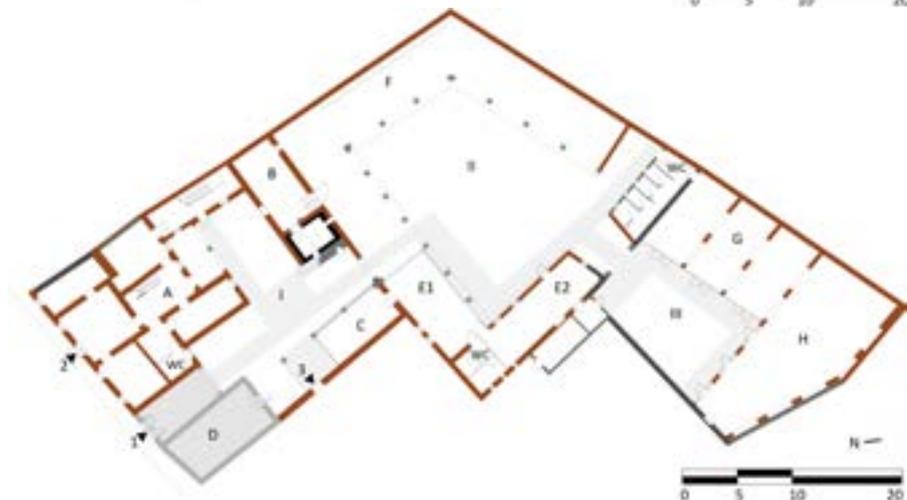
Figure 6: Project plan, ground floor.
 Courtyard I: A) exhibition rooms and tourist agency; B) storerooms; C) tasting rooms; D) Villa Fenu; 1) portal and entrance hall to the courtyard; 2) main entrance; 3) connection to Villa Fenu.
 Courtyard II: E1) cafeteria and E2) kitchens; F) exhibition area.
 Courtyard III: G) workshop and laboratories; H) conference room.
 Red: *ladriri* masonry; black: concrete; dark grey: stone masonry; grey: fired bricks and hollow bricks

The restoration was based on different approaches in each part of the complex (Figs. 5 and 6); raw earth was used even in partially or completely rebuilt parts.

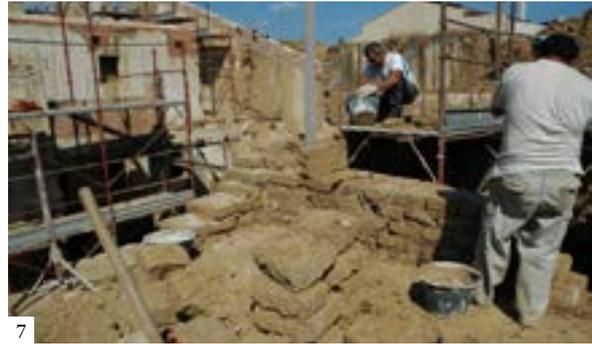
7

Figure 7: In the reconstruction work of building B, the reuse of original *ladiri* in good condition was frequent. The earth derived from the demolition, heterogeneous and with spurious materials, was not reused within the construction site, but was instead reused to fill the land where the earth used for the new bricks was extracted from. (Ignazio Garau)

between opposite walls. Damaged wall portions were demolished and rebuilt with new *ladiri* (Fig. 7) measuring 10x20x40 cm, made by hand with a mix of earth and fibers and laid on an earth, lime, and sand mortar bed. Minimum requirements for *ladiri* were established, such as dimensional stability and compressive strength. Deteriorated masonry surfaces were restored by removing loose parts, reinforcing with wooden sticks or filling with brick flakes and a mixed mortar of natural hydraulic lime, slaked lime, and sand, as well as by applying a mixture of earth and natural fibers in thin layers. The most delicate parts, such as plinths, cornerstones, doorposts, jambs, lintels, and roof-beam bearings, were strengthened with fired bricks (Fig. 8).

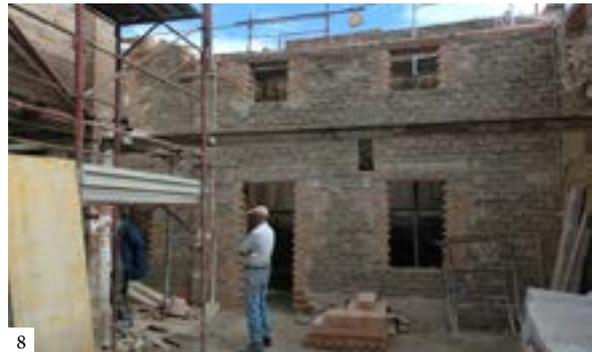
8

Figure 8: The openings were consolidated: reveals and lintels were installed, sometimes with a new element on the inner side, or fired brick platbands, replacing the eroded or fractured bricks (Ignazio Garau)

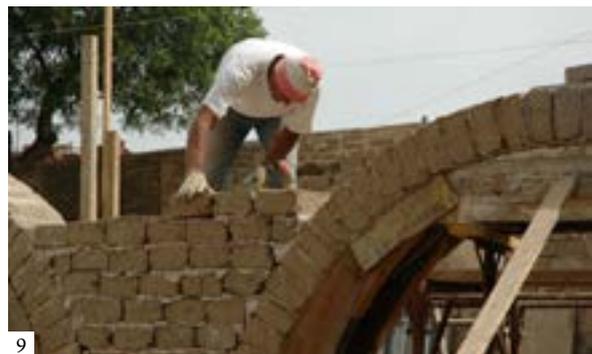
9

Figure 9: Laying of *ladiri* in the construction of the portion of the wall between two arches (Ignazio Garau)

Given their advanced state of decay, the remaining structures around courtyard III were demolished and reconstructed using *ladiri*. Fourteen arches (spanning about 2.5 m) in four parallel walls were built with unfired bricks (Fig. 9). Fired bricks were also used at certain points to counteract the thrust and to support the roof trusses (Fig. 10)

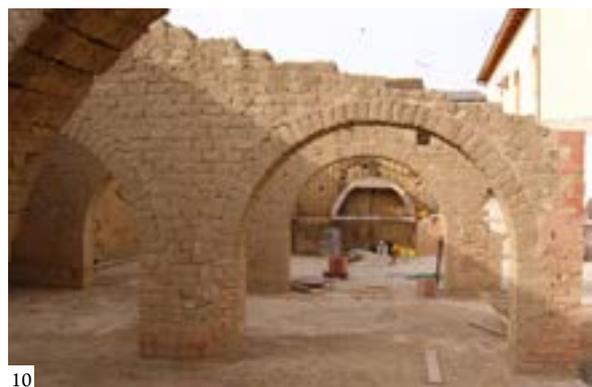
10

Figure 10: View through the arches of courtyard III (Ignazio Garau)

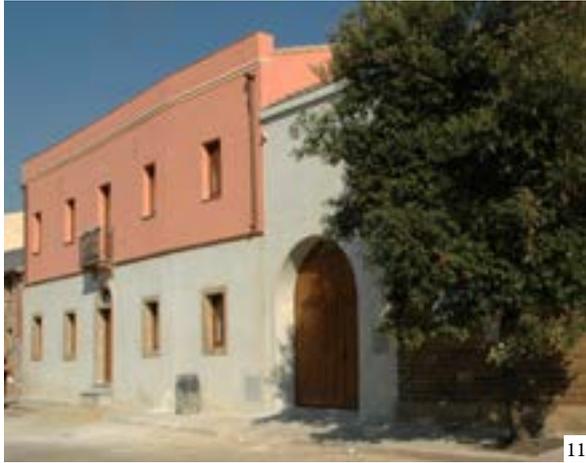
11

Figure 11: The colour of the main façade was chosen to match the shades found in other buildings in Via Santa Maria (Ignazio Garau)

A plaster made of earth, sand, and lime, plus natural fibers such as hay and straw, was applied on all walls. This was rendered with slaked lime and sand and finished with a smooth coat of long-aged slaked lime. The interior walls were limewashed, with color from natural earth pigments. The exterior walls were finished with two coats of a breathable, weather-resistant mixture of slaked lime, mineral additives, natural earths and oxides (Fig. 11).

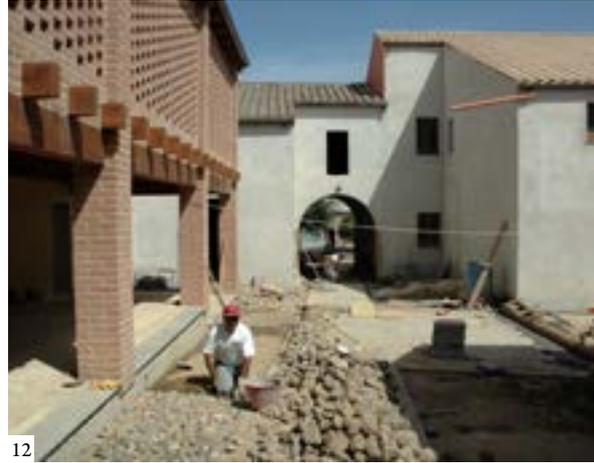
12

Figure 12: Various stages in the construction of roofs: reed mats above the battens, non-woven fabric and EPS foam panels with a bituminous sheathing, curved tiles laid on lime mortar (Ignazio Garau)

The roof structure was rebuilt with solid fir beams in the original configuration, while in the buildings by courtyard III the trusses were formed with laminated glulam beams. The roofing combines industrial and natural materials (Fig. 12). In the outdoor areas, the cobblestones were taken up and reused (Fig. 13). Irregular slabs of Serrenti trachyte were laid dry on the main paths.

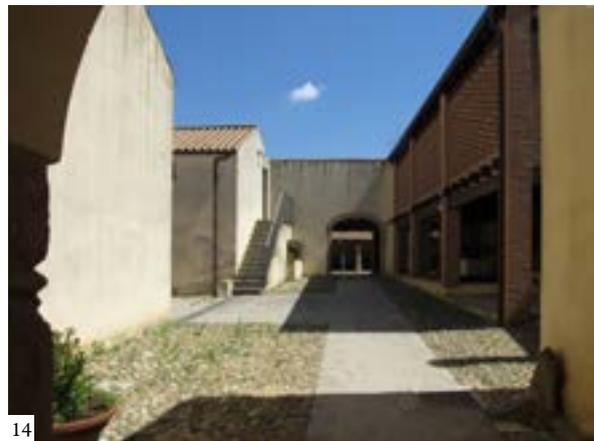
14

Figure 14: Courtyard I as seen from the entrance hall (1): on the left the staircase leading to building B, on the right building C made of fired bricks on the second floor, while glass curtain walls enclose the rooms on the ground floor (Ignazio Garau)

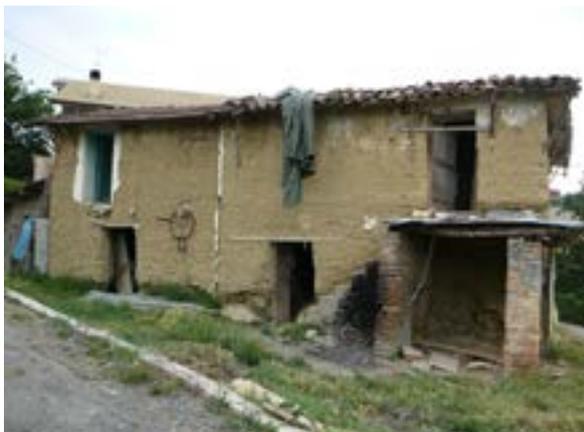
Figure 17: La Casa di Teresa before the intervention, view of the south-east elevation. (CEDTerra)

Before the restoration, the building retained most of its original elements, but due to its abandonment and lack of maintenance since 1967, the incorrect dimensioning and anchoring of the walls, the absence of protective render, and the partial collapse of the roof, it was progressively deteriorating. The chimney had been seriously damaged by a fire and heavy-vehicle traffic. Unsound materials had been

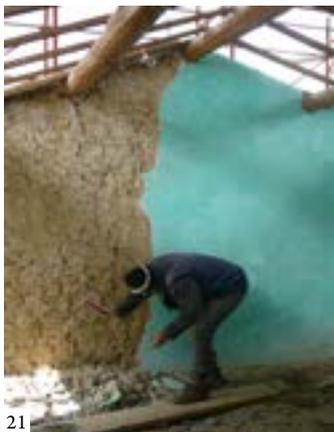
21

Figure 21: Removal of plaster in the west first floor room (CEDTerra)

The inner surfaces of the walls were in good condition but loose parts had to be removed from the outer walls (Fig. 21). Cracks and gaps were consolidated and new *massoni* were laid, made from a mixture of earth, sand, water, straw, and pure gypsum. For every 5 kg of mud mixed with straw, one 20x12 cm loaf-like brick was obtained. The bricks were left to cure overnight wrapped in straw and then laid (Figs. 22 and 23). A structural framework of twigs facilitated bonding with the existing masonry. The connection between the west and east blocks and the repair of the damaged chimney were executed using wooden frames filled with the *massoni* mixture, with wooden formwork. A wood bar was used to level the surface. Two tie-rods were fitted along the long side of the house.

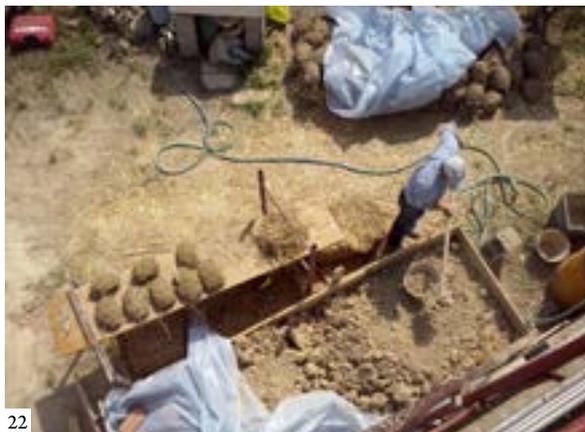
22

Figure 22: *Massoni* production cycle: reuse of earth, recycled from demolished parts and other collapsed buildings, making loaves and curing (CEDTerra)

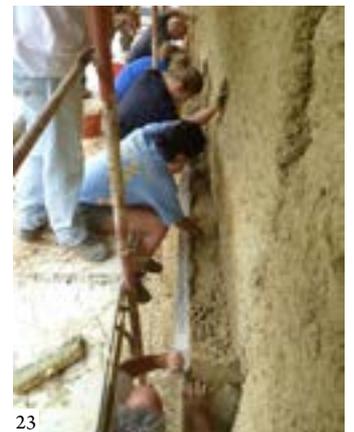
23

Figure 23: Laying of *massoni* by workshop participants: they can be thrown with force, to allow the release of excess water, or laid on beds of dry straw and pressed to adhere and penetrate each pore (CEDTerra)

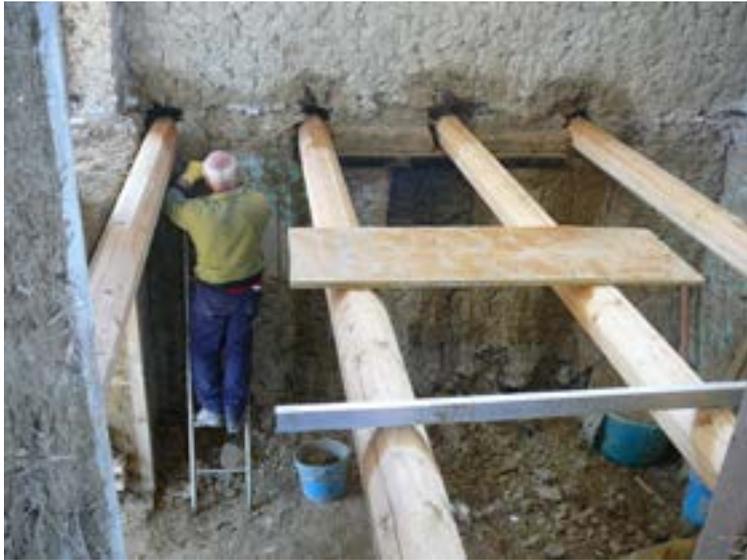
Figure 24: Laying the new beams in the west room (CEDTerra)

The intermediate floors were rebuilt, maintaining the original position of the beams in the east room and rotating them in the west room so as to tie the walls together and to

better distribute the loads (Fig. 24). Joists placed above the beams support the brick flooring.

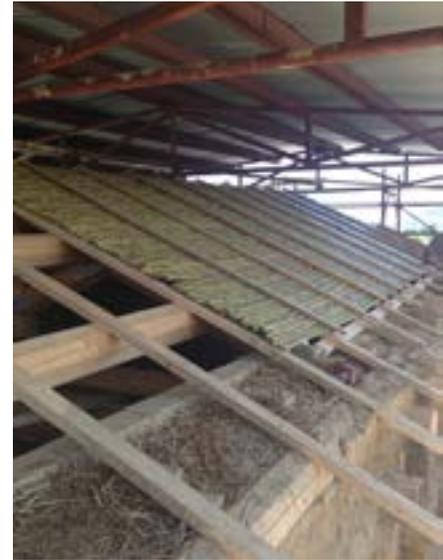
Figure 25: Laying of the laths made during the 2015 workshop (CEDTerra)

Ring beams at the top of the walls distribute the loads of three trusses supporting the main beams and rafters. On the east half of the roof, laths covered with 10 cm of straw and earth were laid, and on the west half, wooden boards waterproofed with a membrane (Fig. 26). A layer of pressed

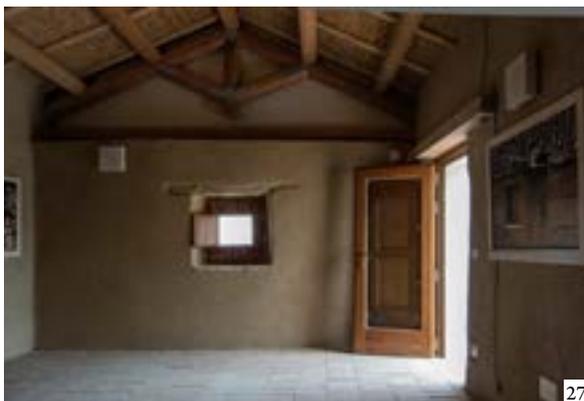
27

Figure 27: New internal staircase in the west portion. The tie-rod added during the renovation runs along the wall

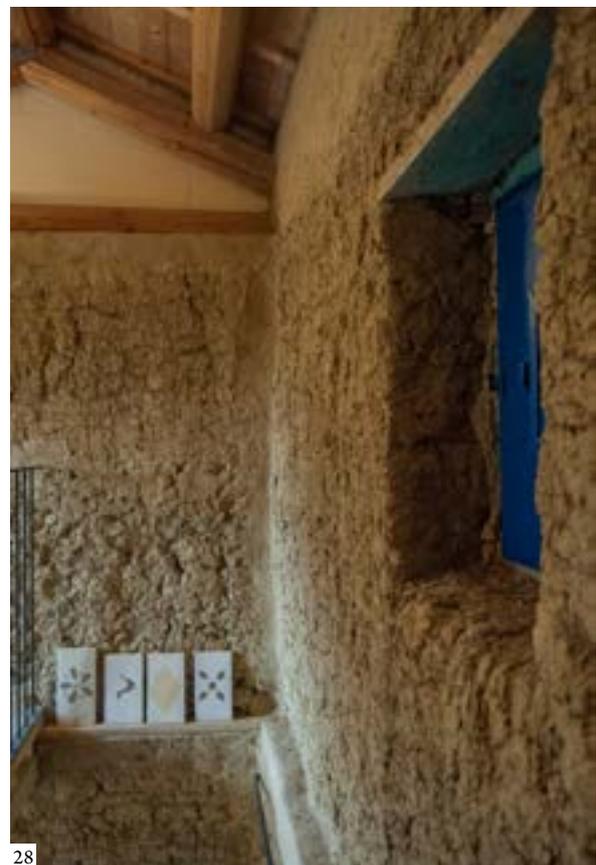
28

Figure 28: *Massoni* walls left without plaster on first floor to the west
